Chapter II. Background Information and Activities in Support of the Second Phase of the Karst Study

Introduction

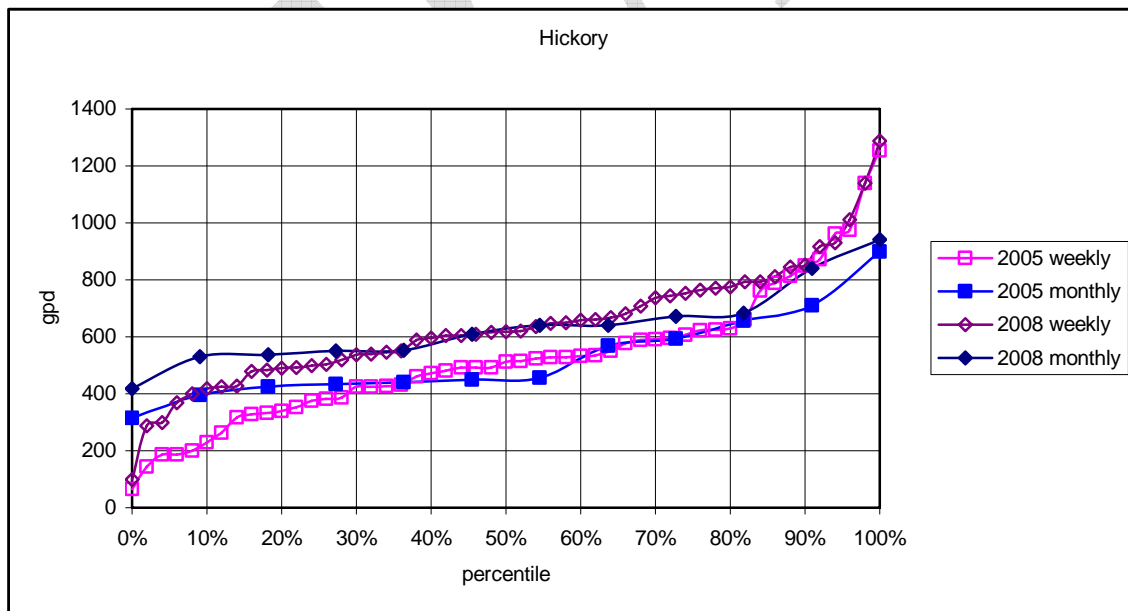
Figure 0-1. Distribution of weekly and monthly water use data for the Hickory bath house (design flow =1200 gpd)

Figures 1 and 2 show the distribution of weekly and monthly average water uses for the two sites. Table 1 shows the statistical characteristics of water use. All four yearly series of observations show that the longer averaging periods tend to hide the very low and very high water use values.

These data resulted in an average peaking factor of 2.4 for weekly water use; 1.6 for monthly water use, and 1.2 for quarterly water use. Averaging water use over the two years, the design flow for both systems corresponds to a peaking factor of 2.1, which in this case is about the same as the peaking factor for the 98%-tile of the weekly water uses or approximately the second highest weekly water use in a year.

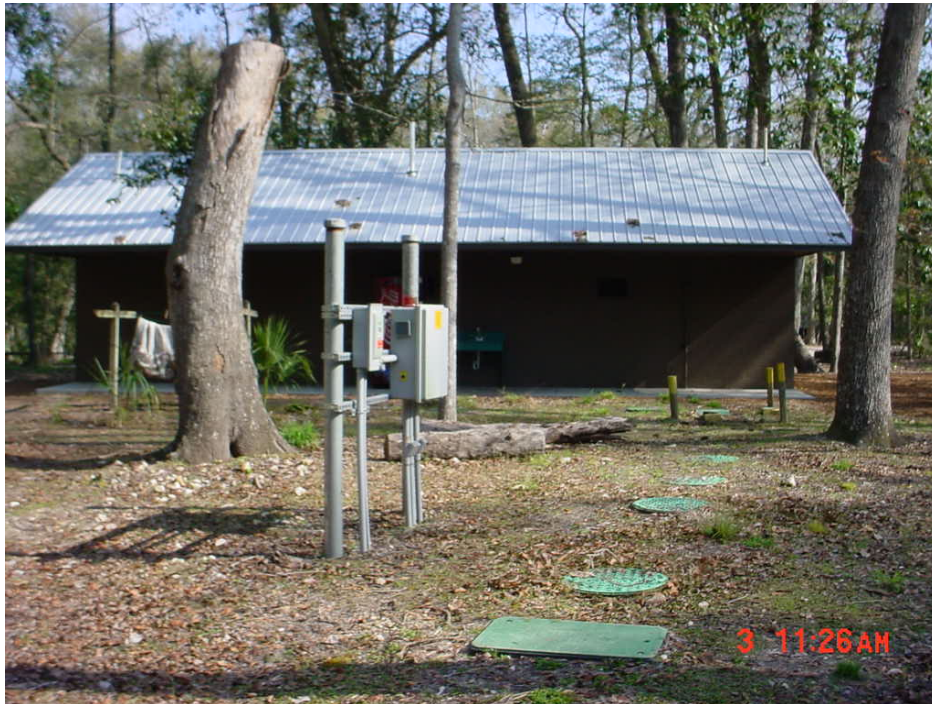
Picture 1. Hickory bathhouse on 03/03/2006. Dosing tank in front, septic tank to the left of posts.

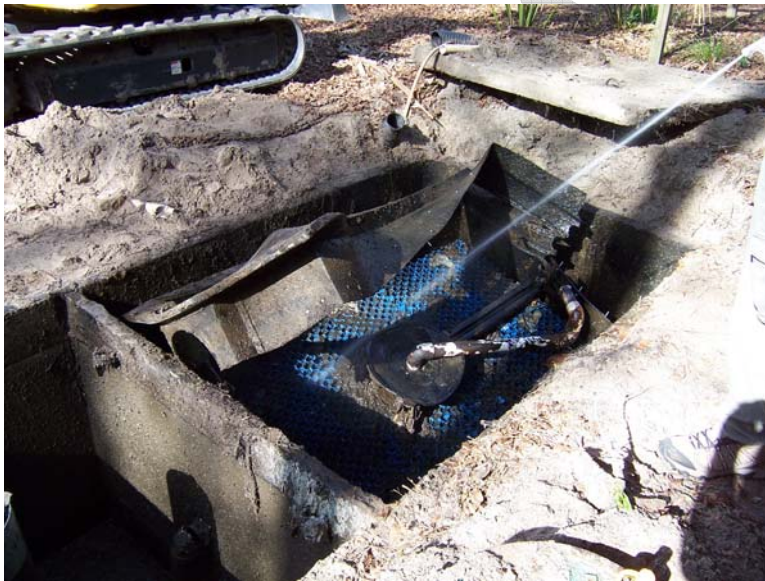
Picture 3. Broken treatment kit, due to increased weight from solids accumulation (note textiles) (March 2009)

The park management pumps all onsite systems out annually during the summer as a matter of routine maintenance. During these annual tank pumpings in 2007 and 2008 it was evident that the system as installed was not capable of treating the wastewater, resulting in excessive accumulation of solids in the kit. The kit was also deeper submerged in the effluent than designed, suggesting a backing up problem. At least in part this appeared to be due to lack of storage space for the large amount of indigestible solids received by the treatment system. During the project period the system had recurrent problems with the pump system, including floats, controls or pumps. This has led to intermittent use of the old drainfield contrary to what had originally been the plan for this study. Maintenance actions resolved issues temporarily until the spring of 2009 when it appears that the pump system is working properly continuously. Concurrently with the 2008 pumping, the tanks were certified by a septic tank contractor and a site evaluation was completed that found an additional drain line in preparations for further modifications. The constraints of the site, including the presence of a concrete pad over the building sewer lines precluded installation of an additional trash tank upstream of the treatment tank. The engineer who had provided the original design developed a revised design that did not

During construction parts of the old kit were damaged (picture 3), so a partially new kit was installed in the new treatment tank (picture 4). During the construction the installer determined that the first tank had been installed not level but uphill with the effluent side about three inches higher than the influent side. The modification was finally completed on March 23, 2009 (picture 5), the and the flow was then directed to the old drainfield.

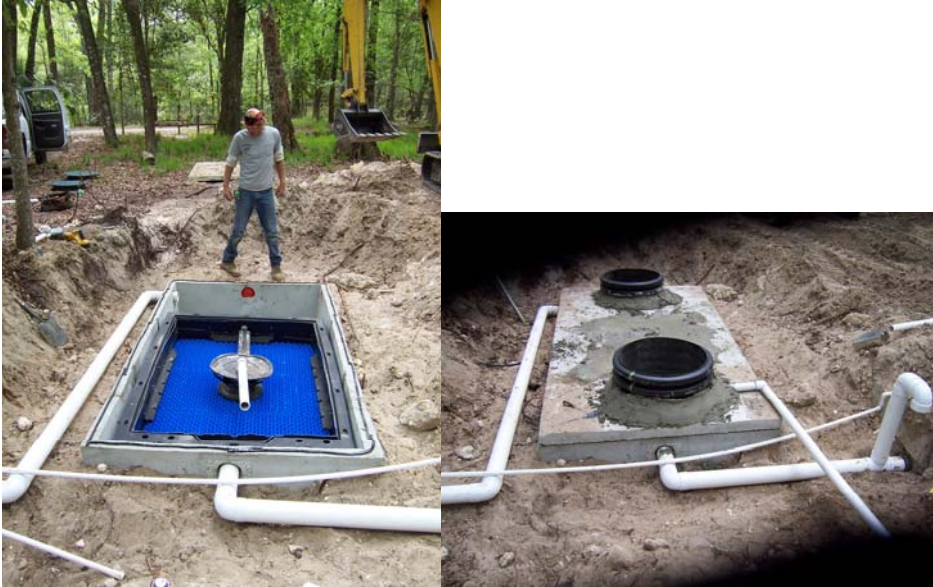
Picture 4. New treatment tank with treatment kit installed March 23, 2009

include phosphorus absorption and replaced the intermediate 750 gallon tank with a 1138 gallon tank large enough to hold the treatment kit. The design then utilized a branch off from the existing low-pressure dosing lines coming out of the existing pump tank to return the effluent to the old drainfield. In this way, the old drainfield is lift dosed.

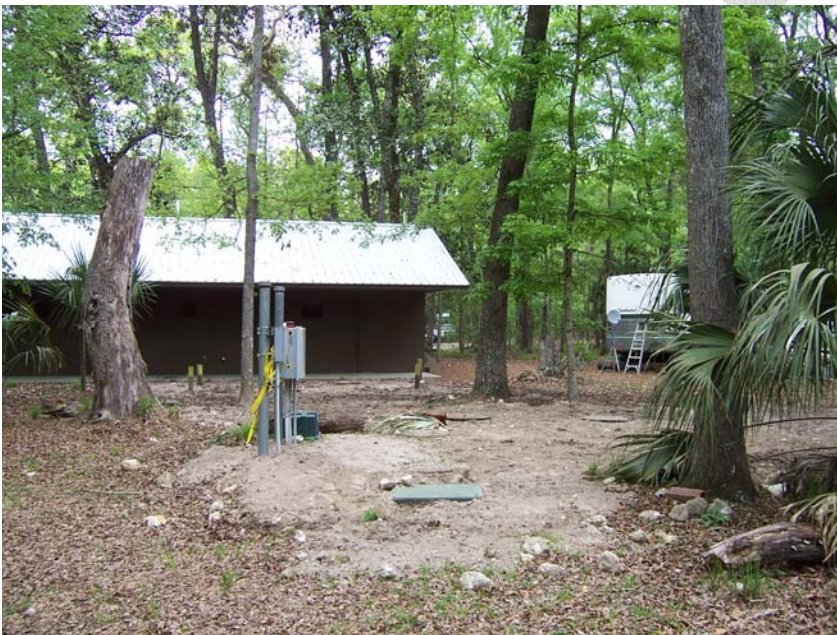
Picture 5. Post-installation site condition March 23, 2009.

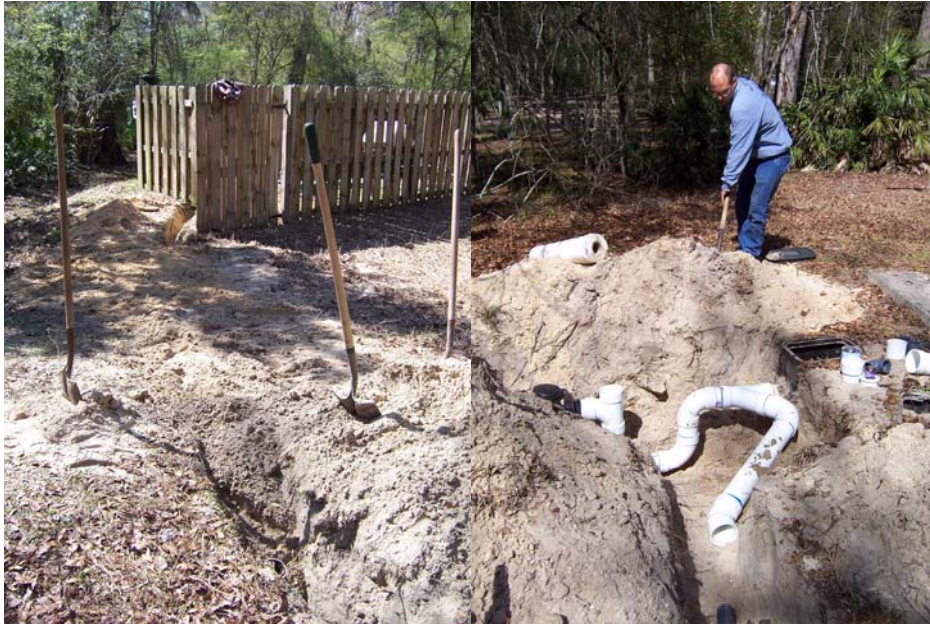
Picture 6. Magnolia II: Installing the return line from the ATU to the old drainfield, 02/24/2009.

The modifications to the system as previously existing were the following (picture 6):

- Install piping to allow alternating drainfield lift-dosing from the existing ATU to either the old existing drainfield for the duration of the research project or to the new existing drainfield
- Install an inspection port to monitor quality of effluent going into the old drainfield
- Replace the existing distribution box and piping between the distribution box and the proposed inspection port

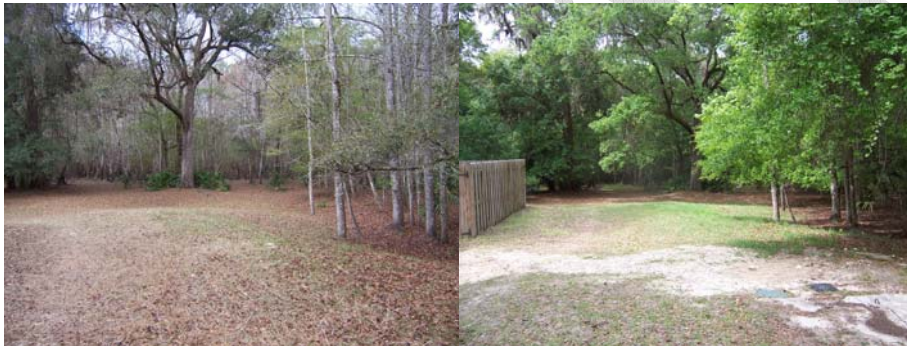
Picture 7. Magnolia II: old drainfield on 02/24/2009 and 03/31/2009, prior to consistent dosing of the old drainfield.

The modifications were made in February 2009, and on March 09, 2009, the ATU-effluent was directed toward the monitored drainfield after verification that the old drainfield was not pressurized by a dose of effluent. During this work concerns about float functioning arose and on March 31, further observations suggested that the on-float was not working properly, and that leakage through the mid-seam of the pump tank might be occurring. On April 02, 2009, the float was replaced and set to trigger pumping below the water level reaches the mid-seam.
